DSTO-TR-0229

Investigation of Fatigue Cracking
on LAU-7/A Launcher Housing

**Airframes and Engines Division
Aeronautical and Maritime Research Laboratory**

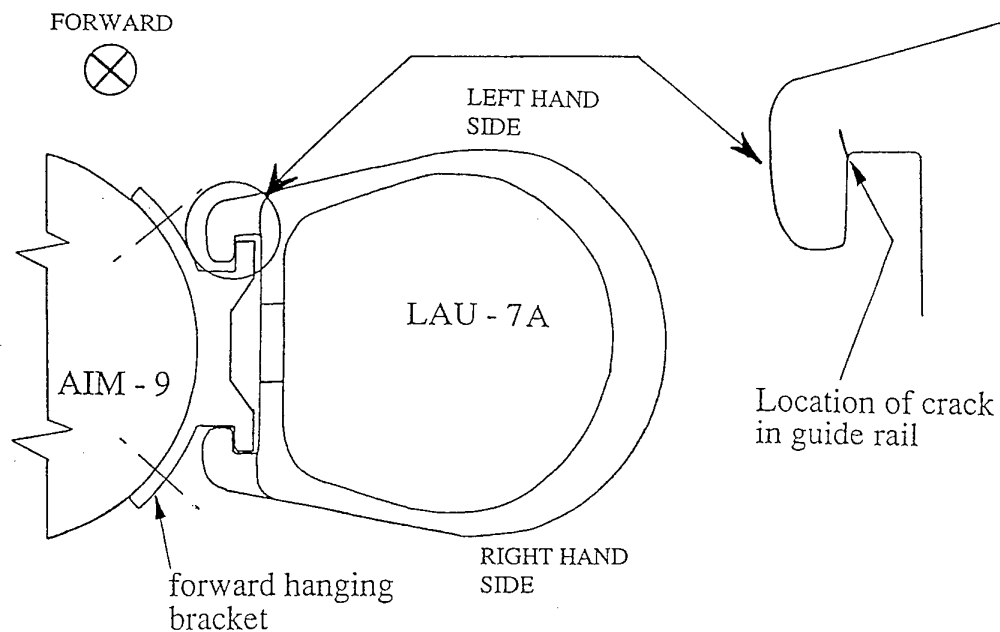
The location of the fatigue crack is shown in Figure 4 and a typical fracture is shown in the inset figure. Left and right-hand sides of the launchers are also defined in Figure 4. At overload failure, when the fatigue cracks have attained critical length, the fatigue cracks are generally of high aspect ratio typically 40 mm along the length of the guide rail and 1 to 3 mm deep. The shallow nature of the cracks creates some considerable difficulty in the inspection of the guide rails. In conjunction with NDISL², No. 481 Wing has developed a new NDI technique which, within the limitations discussed in Section 5.6 of this report, appears satisfactory for the inspection of guide rails. The previous standard technique and the inexperience of operators led to some inaccurate reporting of crack lengths and, possibly, over-estimation of the numbers of launcher guide rails which had cracked in service.

Figure 4. The location of cracking in the LAU-7/A launcher guide rail and typical fatigue crack (inset).

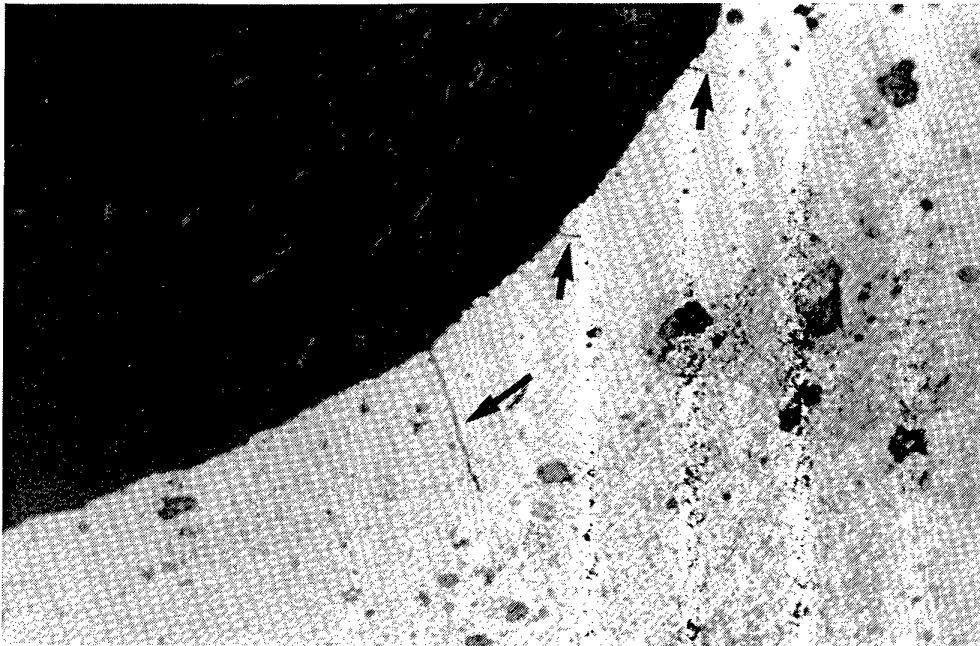
From a metallographic examination of a launcher failed in service, [2] it was apparent that cracking initiated as a result of the stress raising effect of the sharp radius under the lip of the guide rail. This is shown in Figure 5 (after [2]), where it can be seen that initiation of cracking is at a number of sites. The presence of small, intermetallic particles near the surface possibly aided the initiation of cracking. The preliminary scanning electron microscopy has shown that sub-critical crack extension occurred by fatigue. Within this region there was evidence of frequent over loads (causing patches of dimpled rupture) and regions of striation crack growth typical of fatigue. Final fracture by microvoid coalescence (overload) occurred when the crack had grown to a depth of 1 to 3mm, see Figure 6.

Figure 5. Optical micrograph of the region of cracking in the guide rail of LAU-7/A launcher number 0159, from [2]. 6X

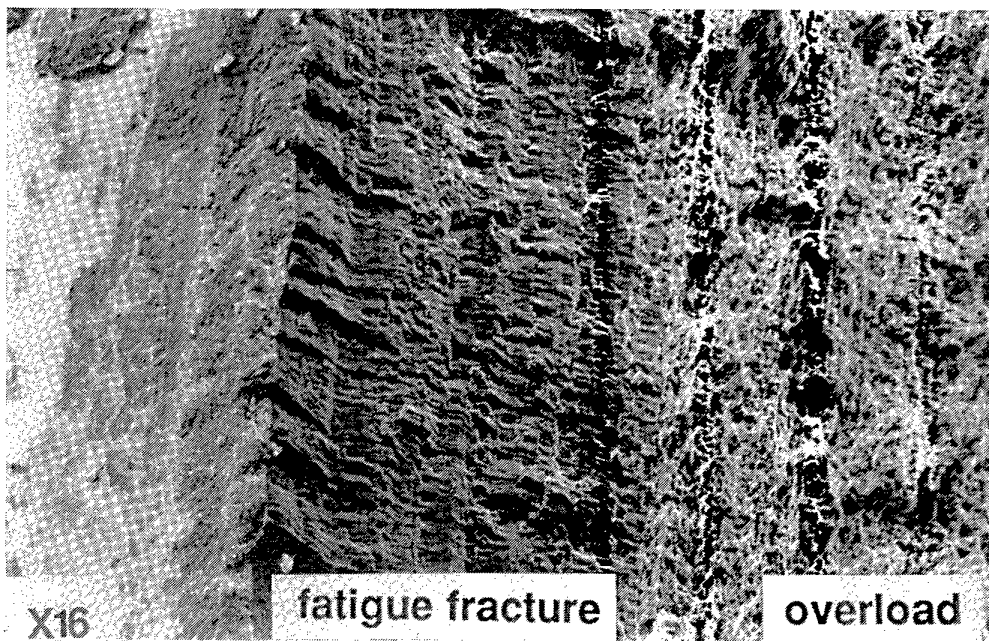
Figure 6. Scanning electron micrograph of the fracture surface from the guide rail of LAU-7/A launcher number 0159, after [2]. 16X

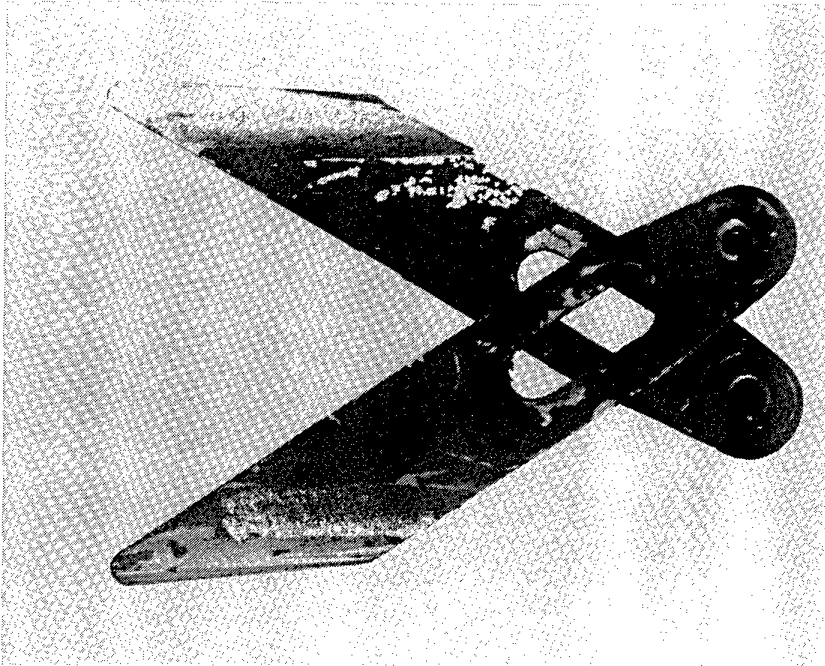
Severe wear to the aft snubbing scissors has been observed, Figure 7, as has the wear to the aft hanging brackets seen in Figure 8. Wear has also typically been reported on the

Figure 7. *Worn scissor blades from the aft snubber mechanism. Scissors were painted black prior to cycling to illustrate the wear which reduces snubbing effectiveness*

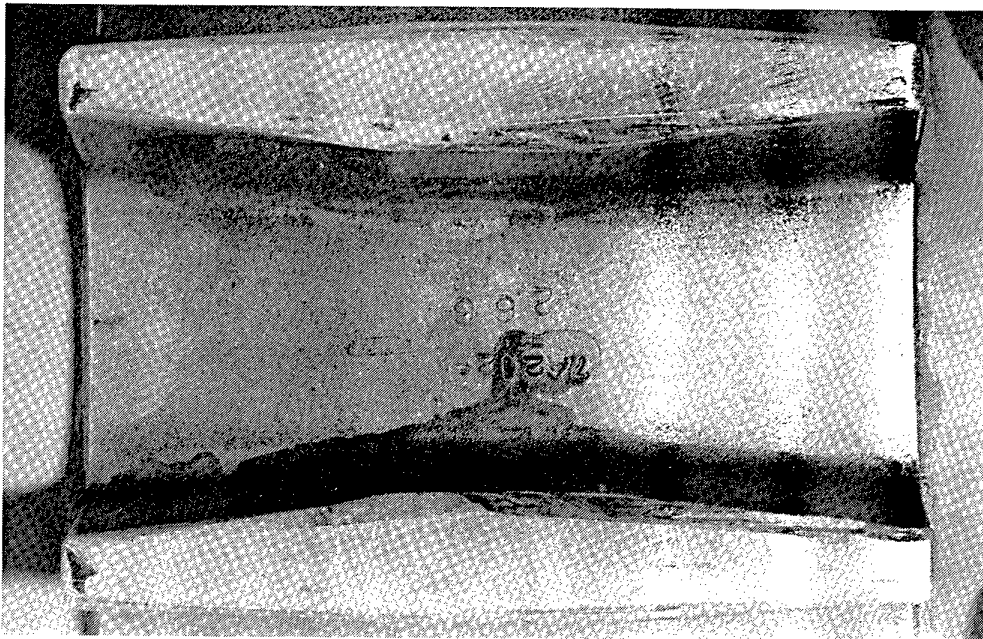
Figure 8. *Wear of the inner corners of the aft hanging bracket corresponding to that of the scissors.*

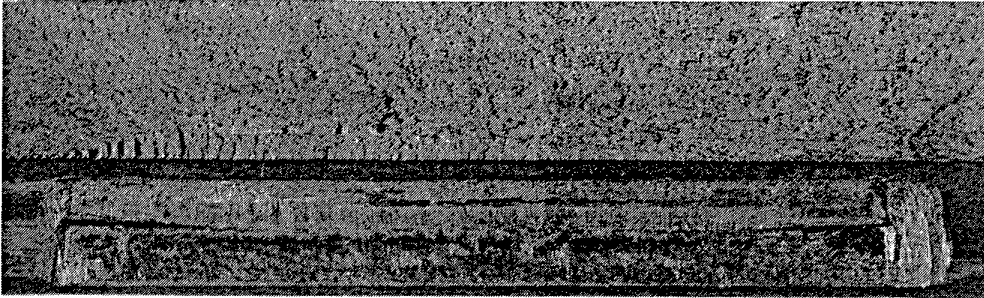
guide rails at the location of the missile forward hanging brackets, Figure 9, and to the missile forward hanging brackets. These types of damage all suggested appreciable movement of the missile during carriage, but there was no evidence to suggest that the cracking in the forward region of the guide rail was initiated by the wear, see also Reference 2. In fact Figures 5 and 9 show that the crack initiation sites are remote from the wear marks produced by the hanging brackets.

Figure 9. *Wear of the inside surface of the rail over the contact zone of the forward hanging bracket. The hills and depressions of the wear marks cause great difficulty for NDI processes. The fatigue crack grown under the test load spectrum is difficult to discern from the overload failure zone.*

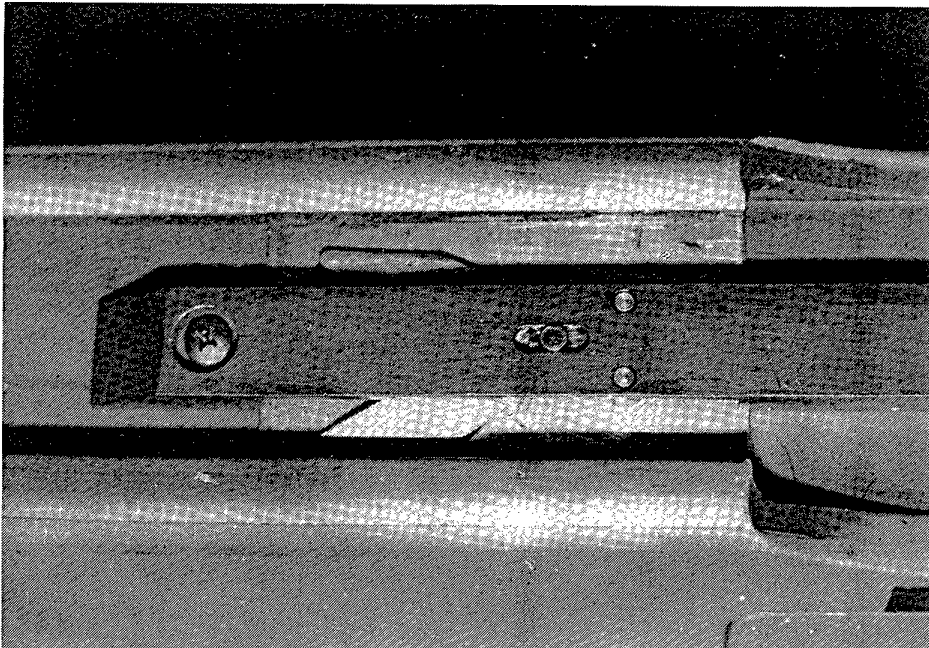
Figure 10. *The RAAF wear plate installed under the aft snubbing mechanism in an attempt to force the missile hanger against the rail and restrict vertical movement.*

In an attempt to overcome the problem of ineffective aft snubbing and presumably decrease load shedding to the region of the forward hanging bracket the RAAF has designed a wearplate which is inserted under the aft snubbers thereby increasing the wedging forces and reducing missile movement, Figure 10. The effect of this plate on the strains at the forward hanger was investigated. Similarly, in an attempt to decrease the loads at the forward hanging bracket, the Canadian Forces have designed sets of teflon cylinders to react aircraft loads directly onto the launcher housing rather than through the guide rails, Figure 11. As an aside in the project this configuration was also investigated in the strain surveys.

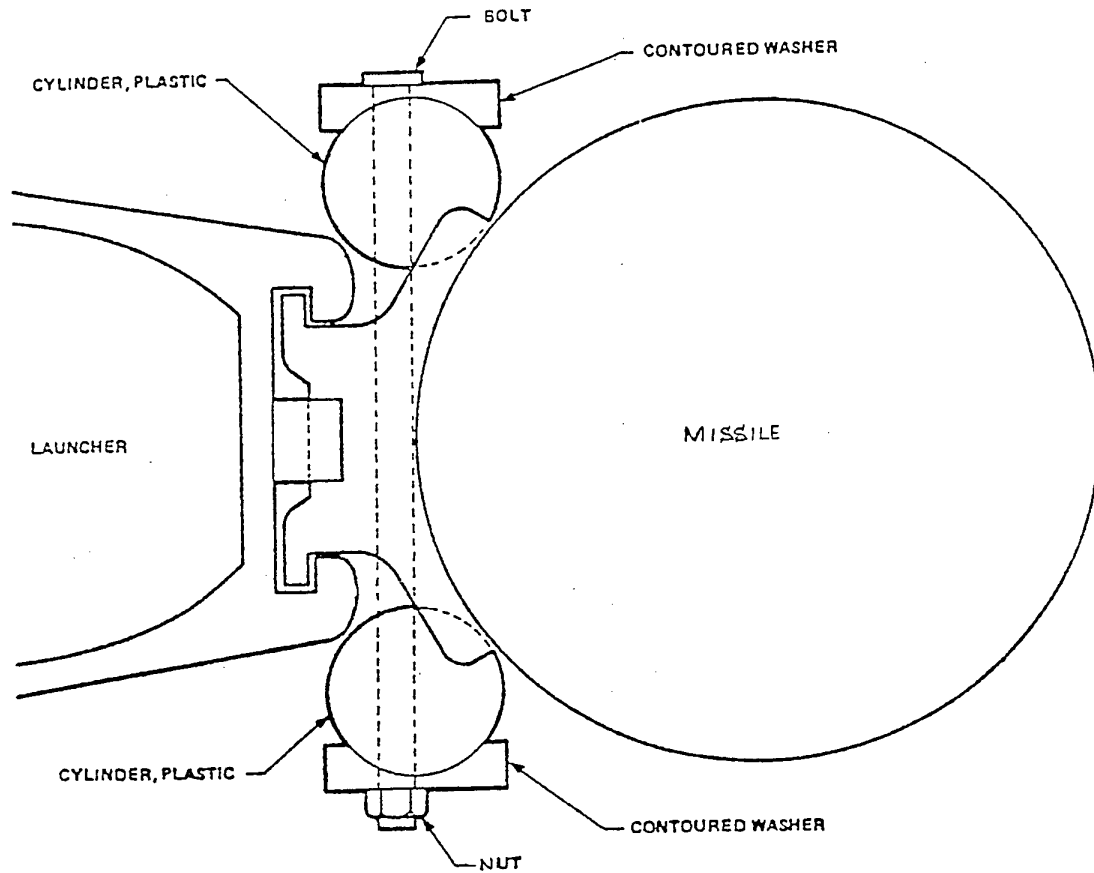
Figure 11. *A cross section of the launcher-missile combination showing the CF design of teflon cylinders to increase snubbing forces. The teflon prevents damage to either part, but soon deforms and loses effectiveness.*

The teflon cylinders introduced by the Canadian Forces were replicated and trialed in just two experiments. The configuration is seen in Figure 11 from [9]. One set of cylinders was adjacent to the forward snubbers and one set attempted to restrict missile vertical movement at the aft snubbers. The recommended torque settings were used, but re-torquing was required after only a few high load cycles as the teflon deformed.

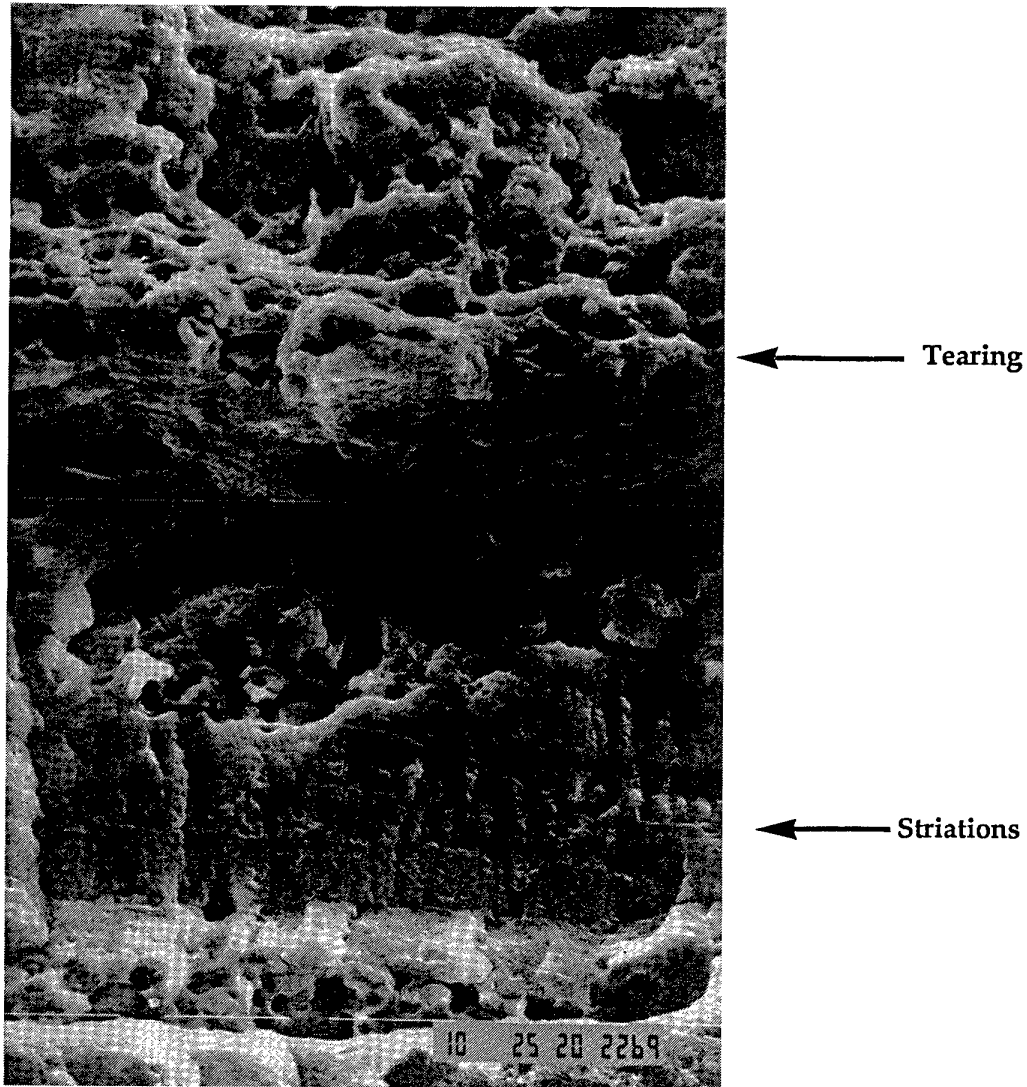
Figure 17. *Another example, from a launcher found overloaded in operational service, of fatigue crack growth interspersed with ductile tearing . This scanning electron micrograph is of launcher S/N 0355.*

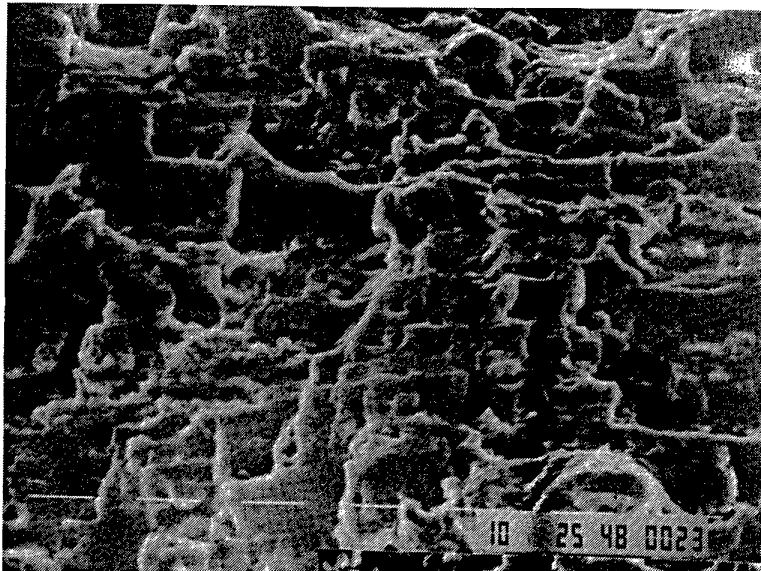
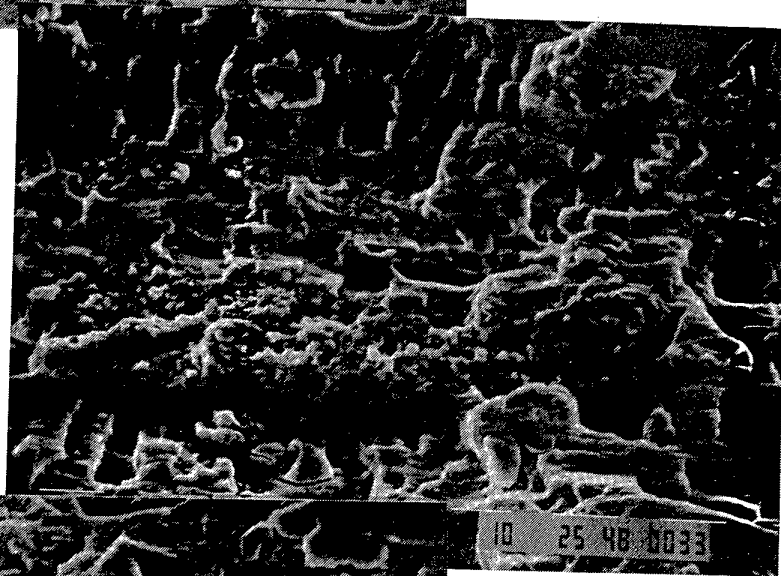
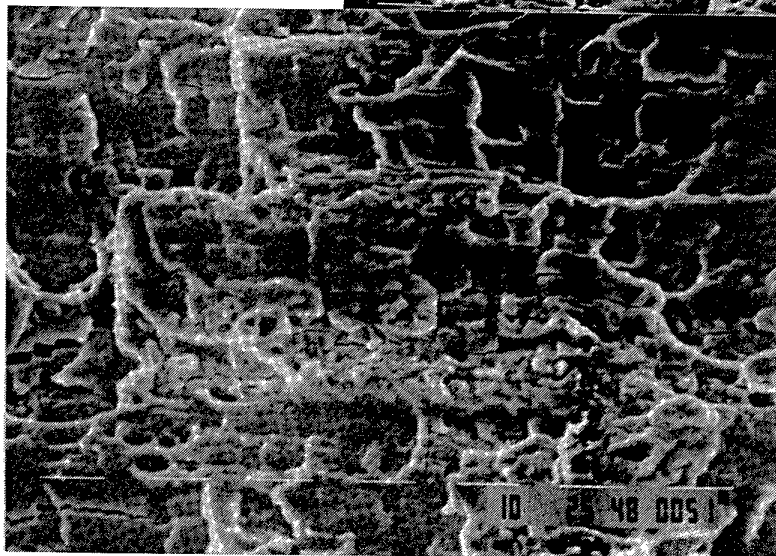
Figure 18. *Fatigue crack growth in guide rails of launcher 71032-012 tested in the laboratory. (a) initial cracking in service, (b) Nz spectrum factored by 3.0, (c) final stages of cracking with spectrum factored by 2.5*

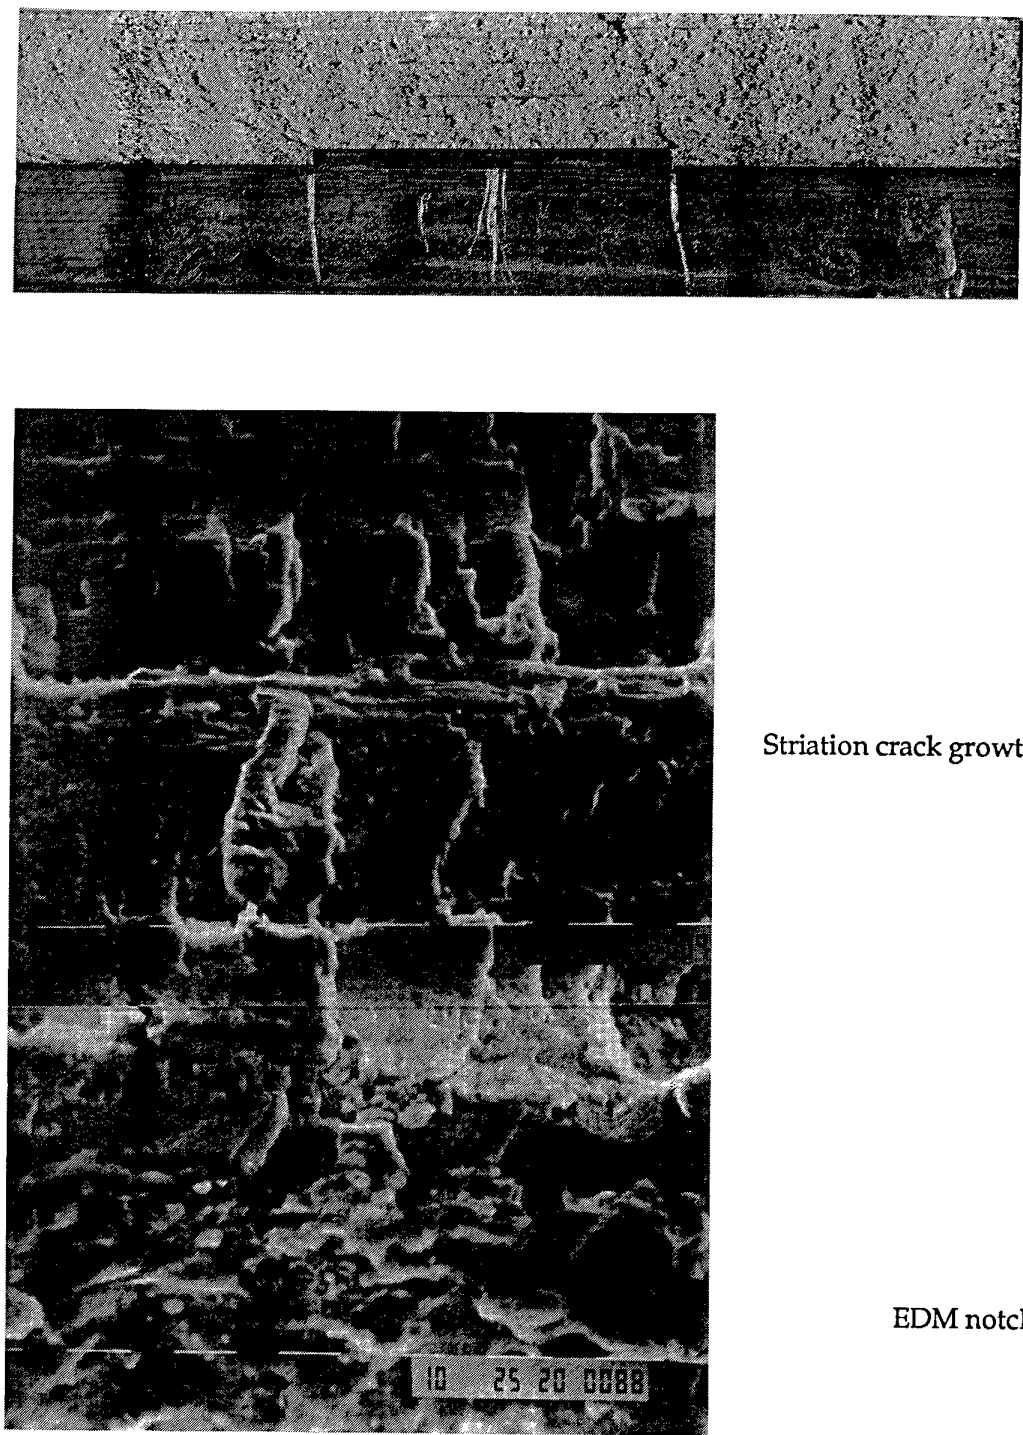
Figure 19. *Fatigue crack growth from an EDM notch in the guide rail (inset) of launcher 0175. The delineation between the melted grains of the notch and the sharp edges of the striation crack growth is difficult to discern.*

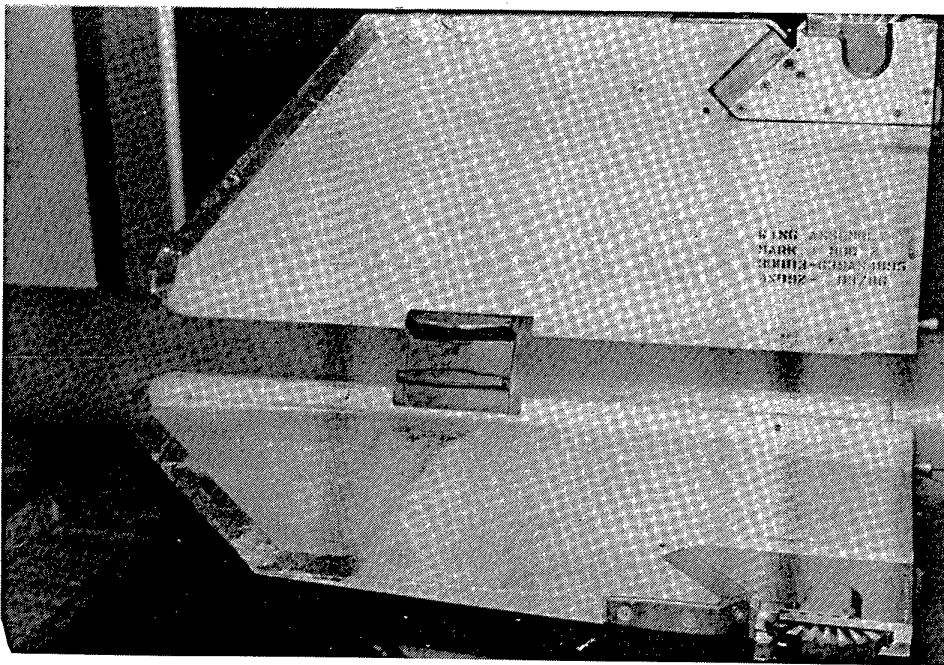
Figure 24. Dark debris particles deposited on the fin as a result of wear at the aft hanging bracket during fatigue testing.
